WEST AUSTRALIAN PETROLEUM REANALYSIS OF SALADIN A PLATFORM and INSTALLATION OF 4th CONDUCTOR

Schlumberger Oilfield Australia Replacement Of Lifeboat Platform On Sedco 702 Modu, 1998

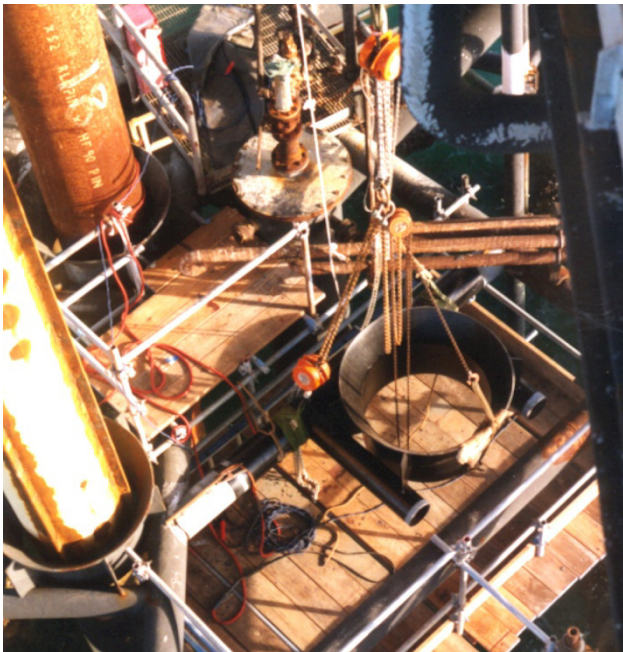
Installation of the conductor guide near sea level

ICON Engineering was engaged to reanalyse the Saladin A platform to support an additional well conductor. The work involved analysis and detailed design work for the conductor guide and hatches. The optimum solution chosen utilised a single conductor guide just above water and avoided any installation work below the water surface.

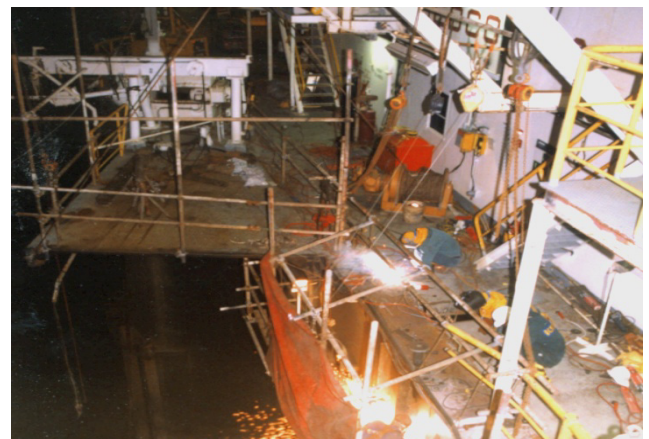
ICON was commissioned by Sedco to carry out an urgent repair on a lifeboat platform and main girder damaged during a mooring operation as it was leaving Dampier in Western Australia. The work required the damage to be assessed from photographs and replacement components designed such that they could be prefabricated in Queensland and be ready for the rig as it passed by on its way to New Zealand.

After the damaged platform was removed repair work was done on the main girder.

ICON personnel boarded the rig while it was under tow and made preparations for the work such that the new steelwork could be brought on board and installed whilst the rig was still in protected coastal waters.

The work was completed without any delay to the rig's tow progress and the rig was ready to commence work on arrival in New Zealand.

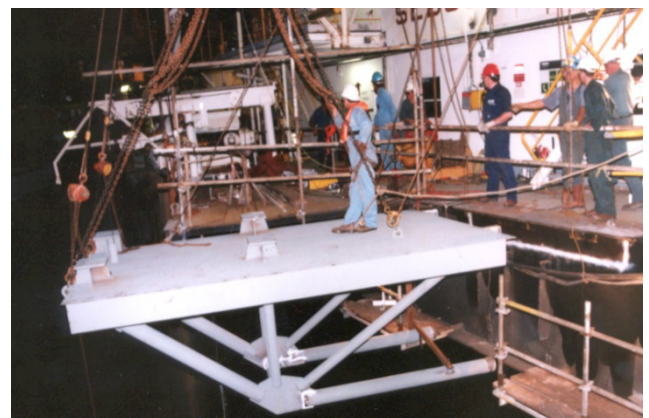
Lifting the new deck section into place
